WATER POLLUTION CONTROL RESEARCH SERIES ● 11022 DPP 10/70

Combined Sewer Temporary Underwater Storage Facility

COMBINED SEWER TEMPORARY UNDERWATER STORAGE FACILITY,

Meloy, T. P.
Langley, B. C.

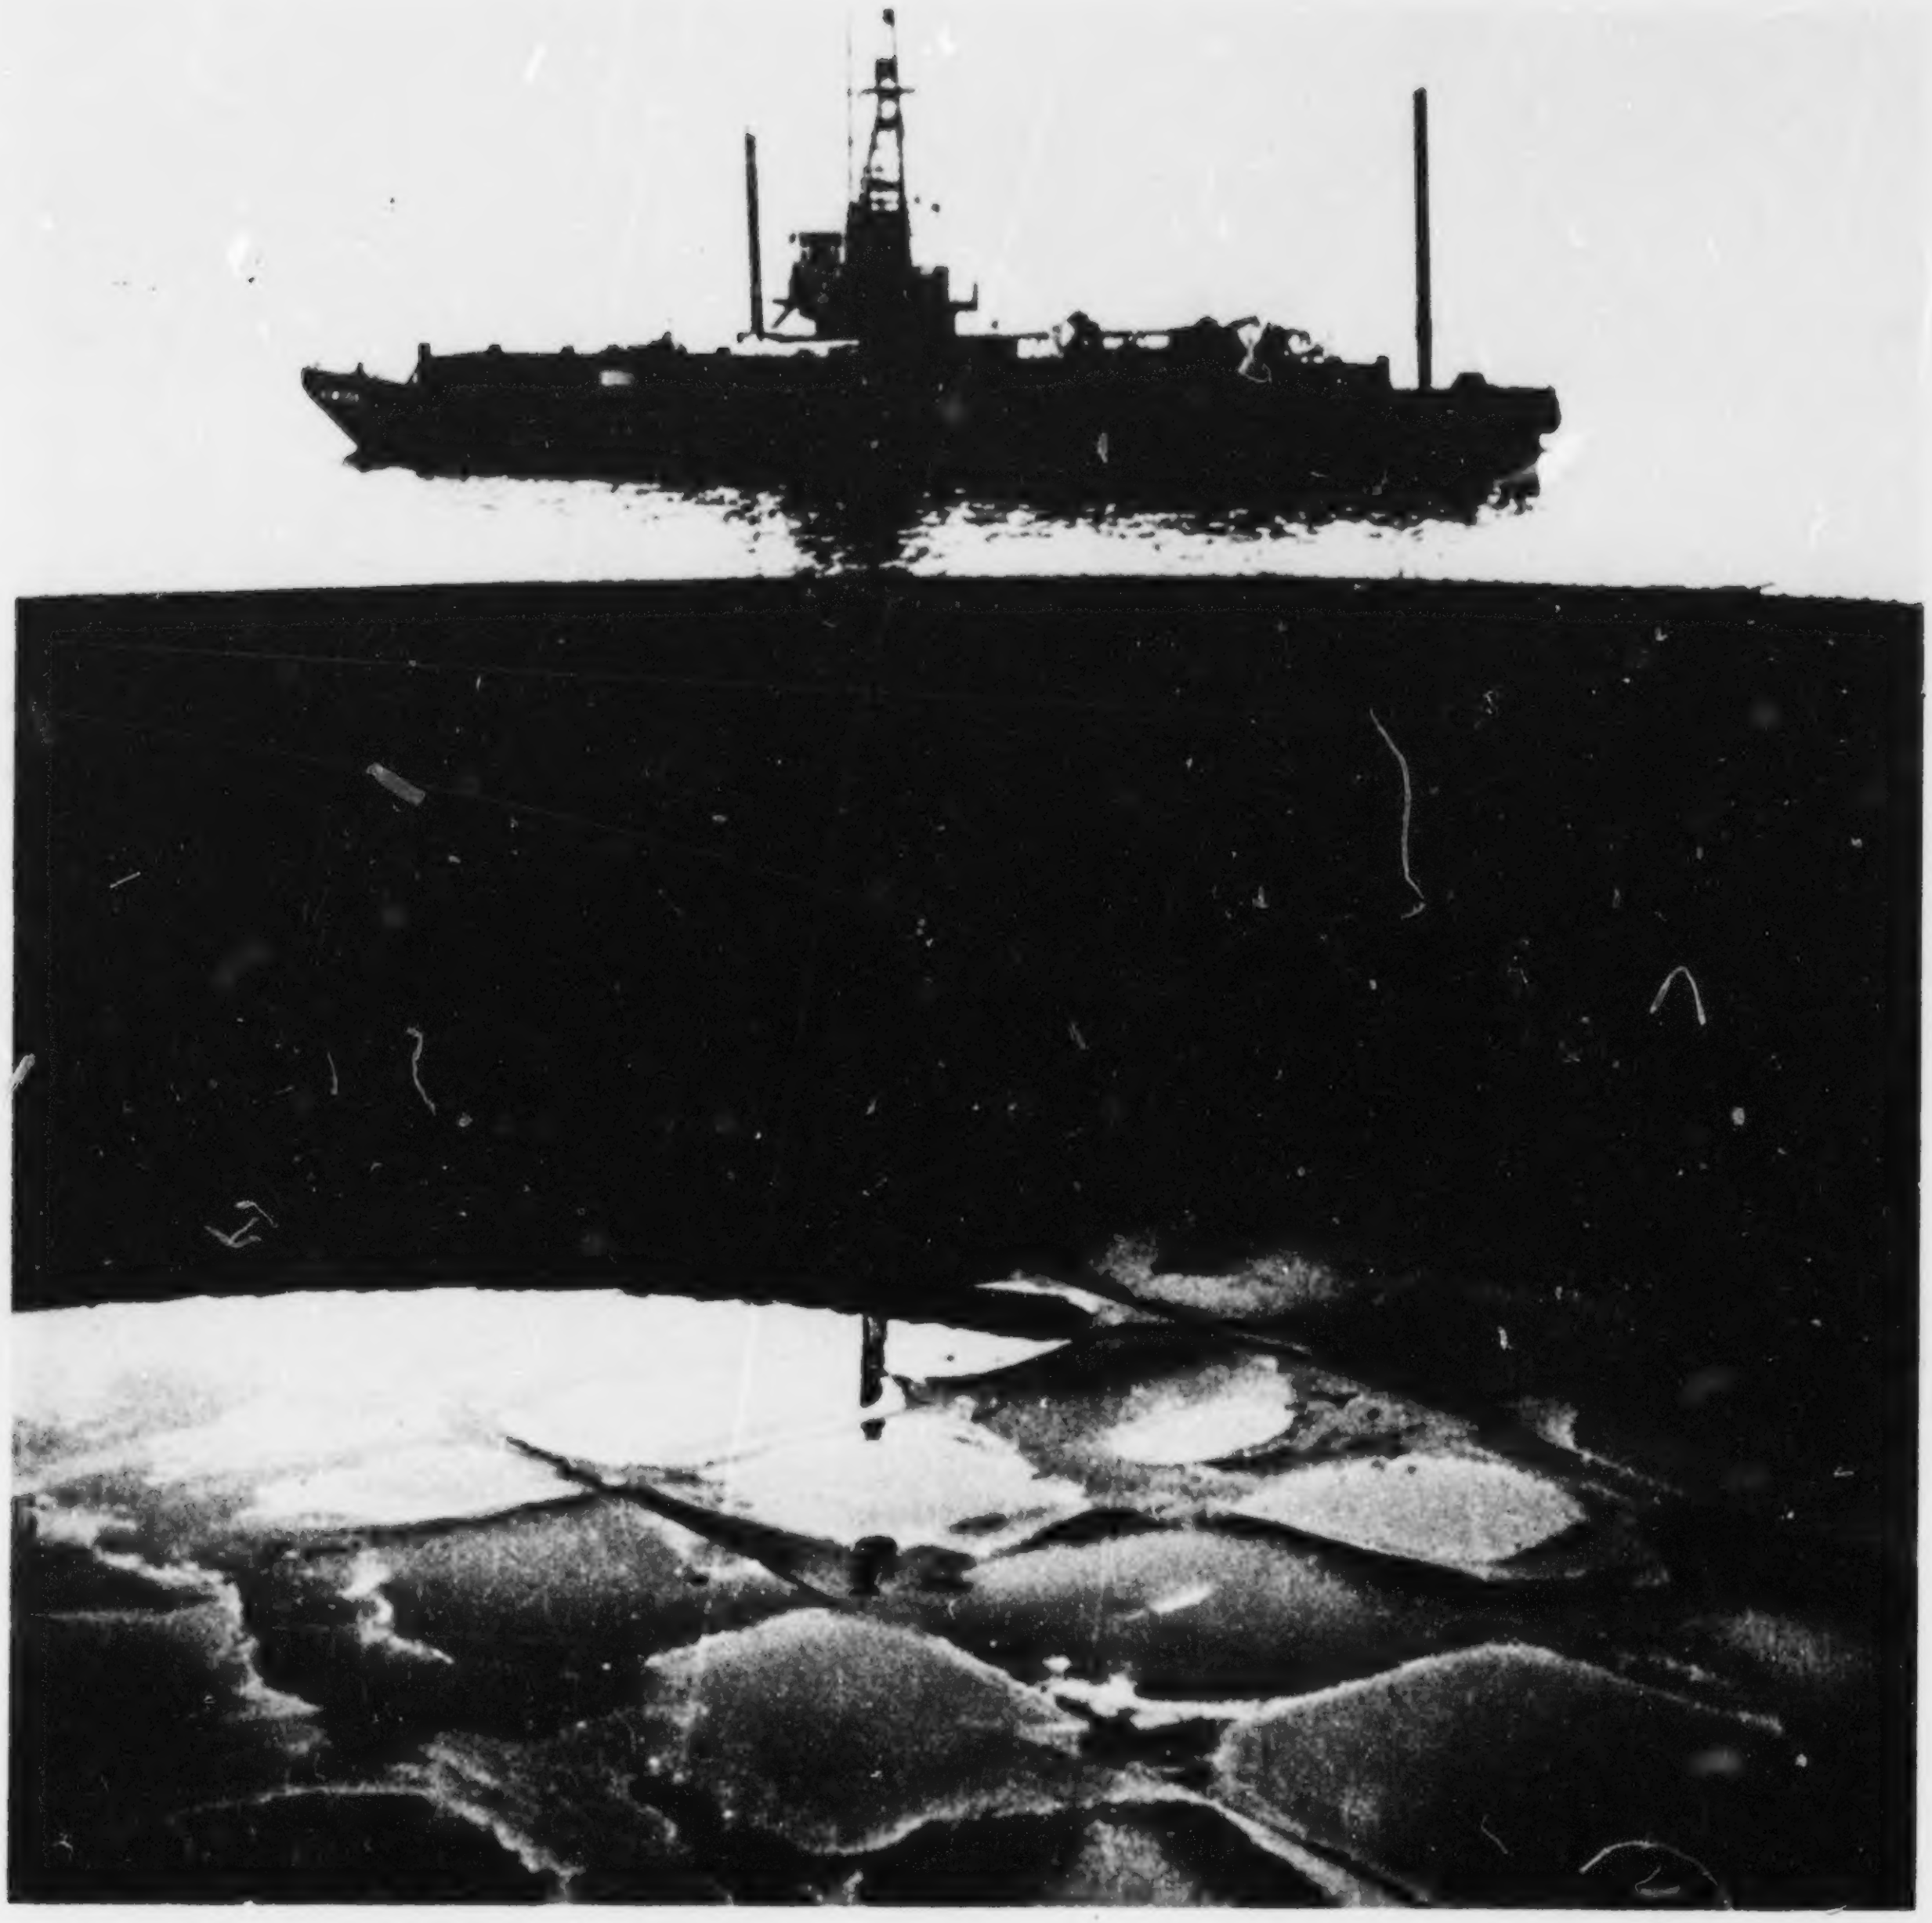
Figure 15. Internal View of Storage Tank After Removal

The inside of the steel tank was relatively free of sludge deposits. This indicates that the flushing procedure and circulation system was effective in keeping the tank clear of settleable solids. Figure 15 shows an internal view of the storage tank. The silt that was observed in one area of the tank was the result of the discharge of external sedimentation from the flexible top into the tank during the removal of the flexible cover.
